**Flood Control Project Maintenance  
Levee Inspections****LMA District Cover Sheet****Spring 2015 Levee Inspection Results****Reclamation District No. 2094 Wathal**

**Levee Inspection Report By Mile - Spring 2015**

Waterway	Bank	Unit Miles	Inspection Start/End	Inspector
Unit No. 01 San Joaquin River	Right	2.78	05/07/2015 05/13/2015	Maksim Khashchuk

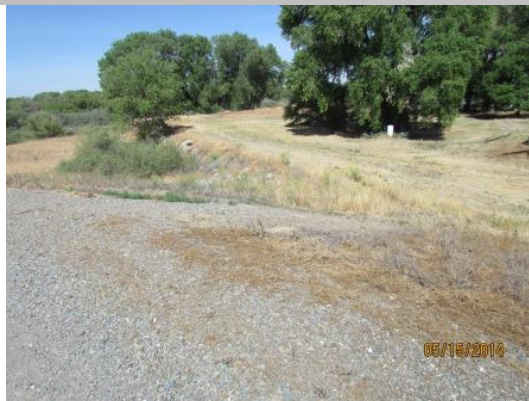
Photo 1 of 1 : SP\_2015\_RD2094\_320\_4\_20150317\_00001.jpg

LM Start	0.10	Rating **	M	Issue No.	4
LM End	0.10	Issue Type +	En	Location *	WS
Category	Earthen Levee			GPS Latitude/Longitude	
				Start	End
Item	Encroachments			37.771685 °	37.771685 °
				-121.300239 °	-121.300239 °
DWR ID	DWR_RD2094_01_s_2012_4				
Action/Comments					
Ramp Inspector Comments: An access ramp has been built on the water side and extends into the channel. This could potentially alter the channel capacity. This item was also noted in the USACE comments.

Tire marks shown onto the ramp from levee. Raised area extends to the trees in the background in the center of the photo.

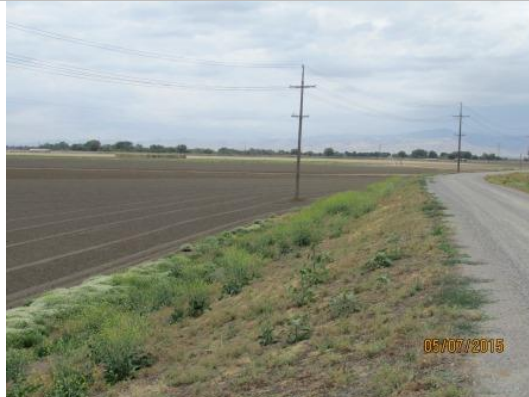
Photo 1 of 1 : SP\_2015\_RD2094\_320\_6\_20150511\_00005.jpg

View of the vegetation on the landside levee slope.

LM Start	0.86	Rating **	M	Issue No.	6
LM End	0.91	Issue Type +	Ma	Location *	LS
Category	Earthen Levee			GPS Latitude/Longitude	
				Start	End
Item	Vegetation			37.764988 °	37.764199 °
				-121.293298 °	-121.293544 °
DWR ID	DWR_RD2094_01_s_2015_6				
Action/Comments					
Control annual grass and weeds on the levee slopes and easements.

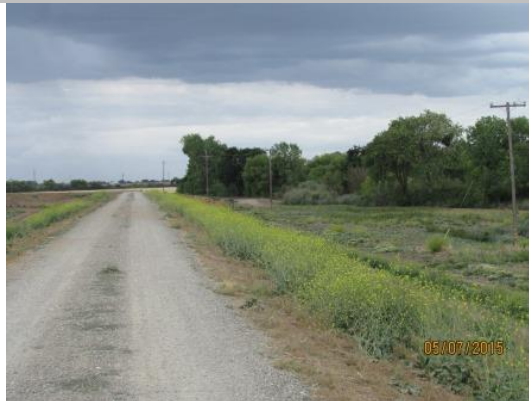
Photo 1 of 1 : SP\_2015\_RD2094\_321\_1\_20150511\_00001.jpg

View of the vegetation on the waterside levee slope.

LM Start	0.02	Rating **	M	Issue No.	1
LM End	0.02	Issue Type +	Ma	Location *	WS
Category	Earthen Levee			GPS Latitude/Longitude	
				Start	End
Item	Vegetation			37.759373 °	37.759373 °
				-121.299962 °	-121.299962 °
DWR ID	DWR_RD2094_02_s _ 2015_1				
Action/Comments					
Control annual grass and weeds on the levee slopes and easements.
